CANADIAN FORCES FLIGHT SAFETY INVESTIGATION REPORT (FSIR)

FINAL REPORT

FILE NUMBER: 1010-188906
DATE OF REPORT: 16 December 2004

AIRCRAFT TYPE: CF188 Hornet
DATE/TIME: 311938Z July 2001
LOCATION: 3 Wing Bagotville, QC
CATEGORY: "C" Category Accident

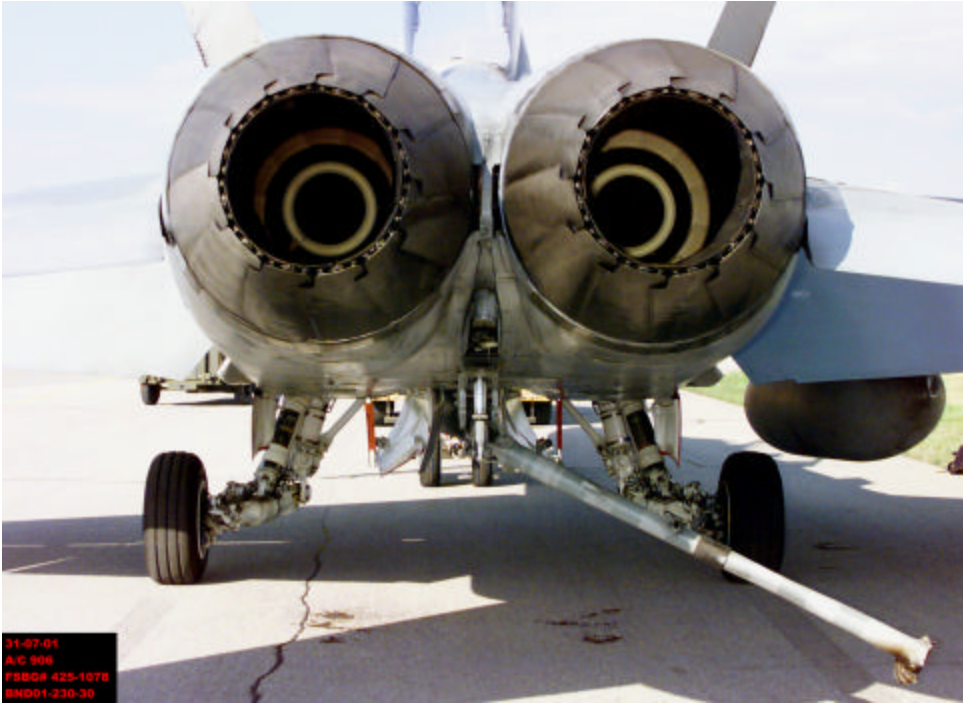
The aircraft sustained "C" category damage after the arrestor cable failed and its associated fittings struck the aircraft. This also bent the aircraft's arrestor hook to

the right by about 70°(Photo 1) and resulted in structural damage to surrounding components, including the structural attachment point for the arrestor hook assembly.

Photo 1: Damage to tail hook and nozzle area.

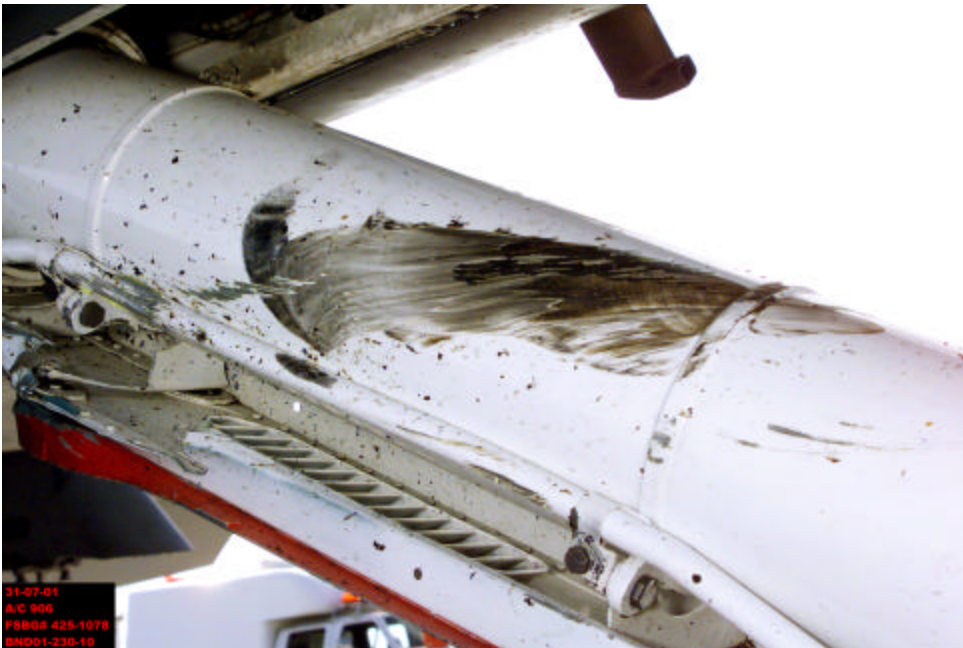
Other damage sustained from the cable strike included scrapes and gouges to components on the nose landing gear (Photo 2) and associated assembly, panels on the right side of the aircraft, the right external fuel tank and associated assemblies, and the upper surface and leading edge of the right stabiliser.

Photo 2: Damage to nose gear.

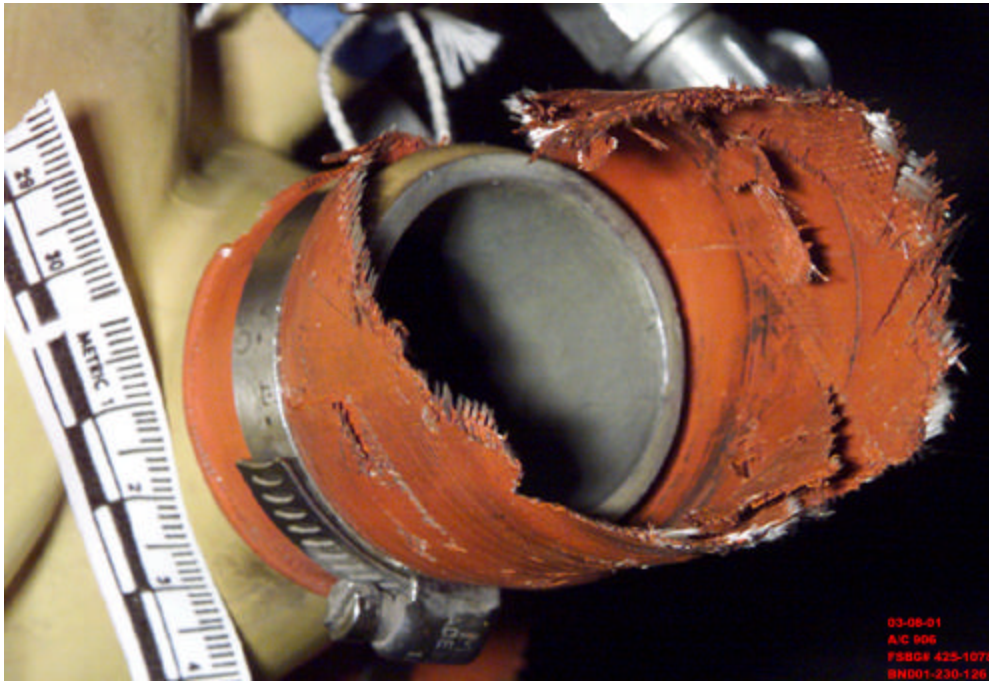
Most of the ECS ducts and components, including the ECS turbine, are located underneath the CF188 in an area referred as the keel of the aircraft (the belly). Panels from the keel area were removed to investigate the ECS. The rubber hose connecting the ECS turbine and the fibreglass duct was found chuffed and disconnected at the turbine attachment point. There was only a small portion of the hose still attached to the ECS turbine and the remains of the rubber hose were found inside the panel removed for access. The other end of the rubber hose was not connected to the fibreglass duct. The end of the fibreglass duct was split and the retaining clamp was found in the keel panel along with other FOD related to the attachment and identification hardware.

Photo 3: ECS rubber hose located between the ECS turbine and the Anti-ice add heat valve.

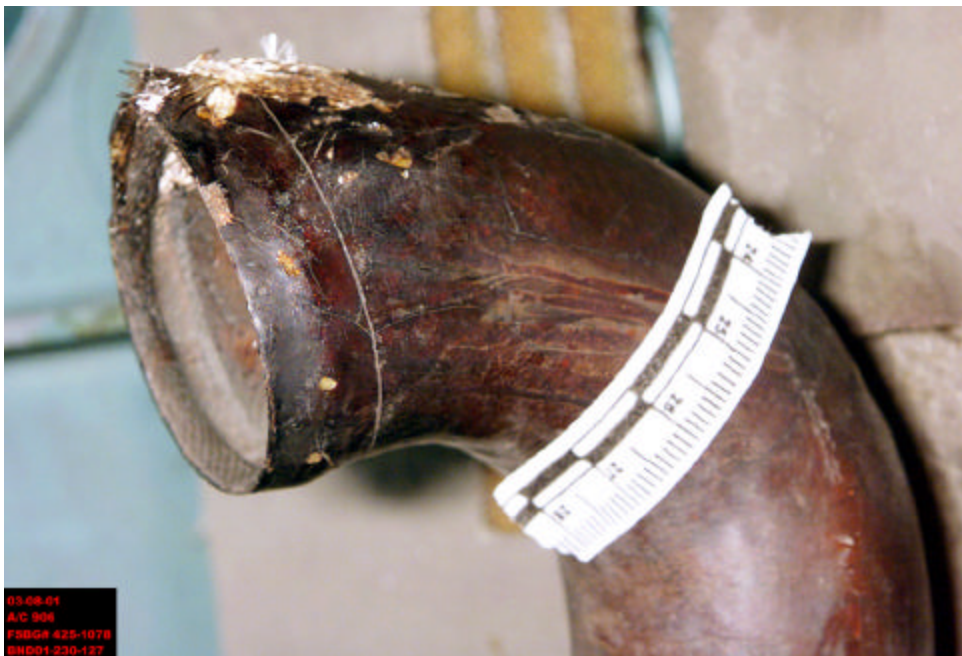
Photo 4: Fibreglass duct, found disconnected and chaffed at the turbine attachment point.

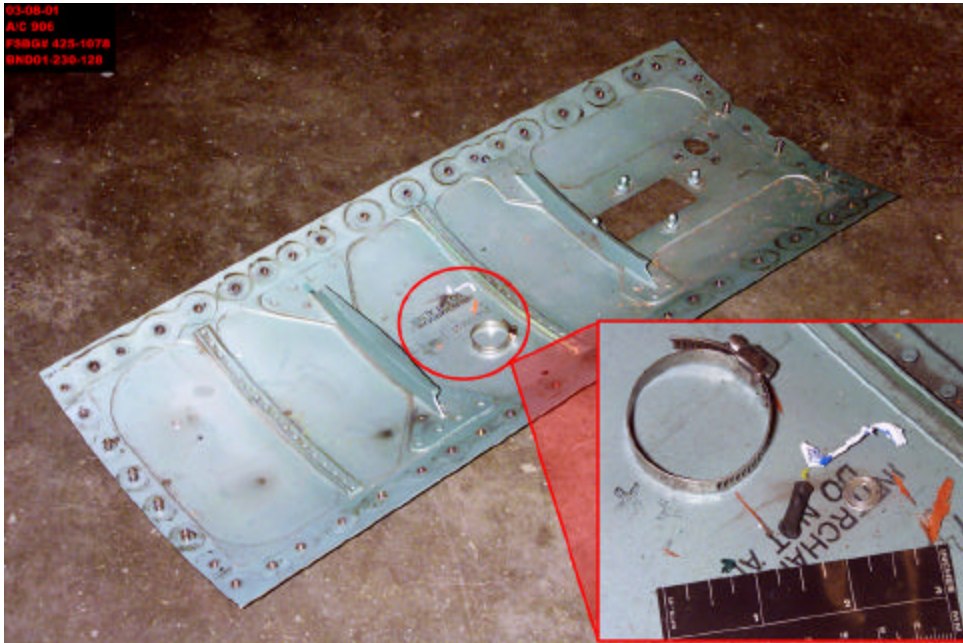
Photo 5: FOD found when the centre line ventral panel was removed to access the ECS.

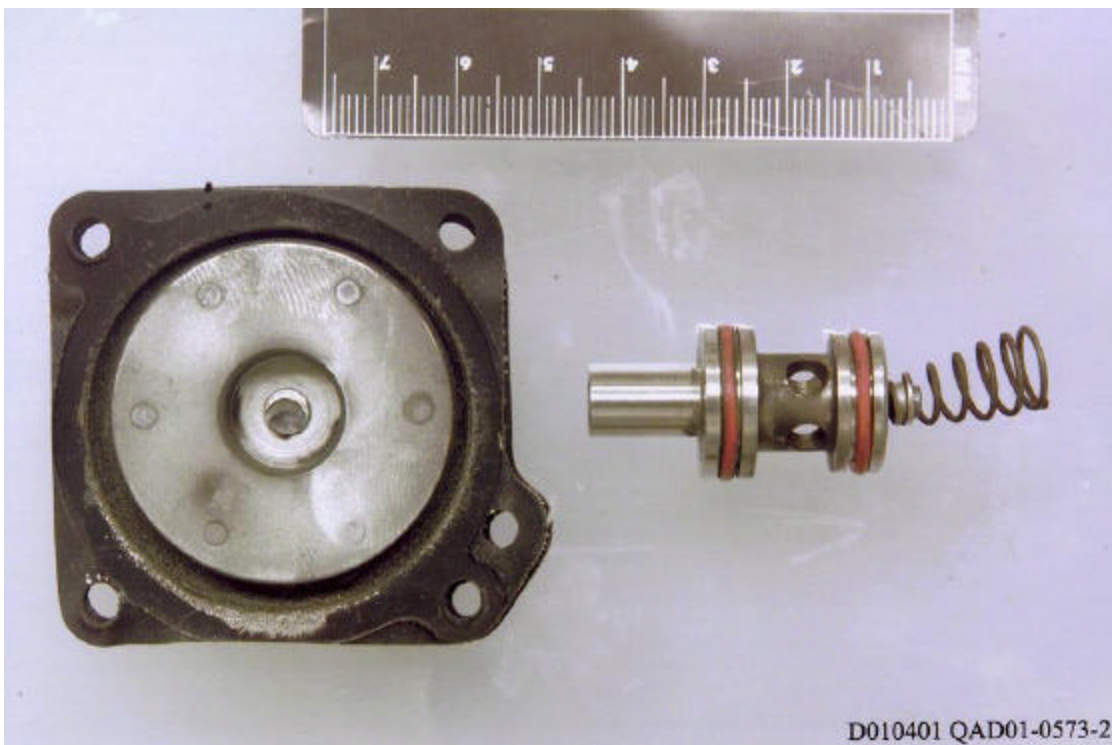
smoke in the cockpit. In an effort to verify if the Valve, Anti-Ice Flow, Temperature Limiting was operating normally, support technicians and a Field Service Representative reconstructed a mock up to reproduce the ECS temperature and pressure up stream of the suspected valve. When the valve was installed in the mock up, the muscle pressure regulator portion of the valve was found to be inoperative. The incoming applied air pressure (upstream) had the same value as the out going air pressure (downstream). In other words, the valve did not regulate the system muscle pressure. To confirm this finding, the same test was performed on a valve known to be serviceable and it was found that air pressure was regulated as designed. Initial analysis of the ECS diagram showed that the accident valve (not regularising the pressure) could not correctly control the temperature and thus caused excessive heat egress into the ECS system. The faulty Valve, Anti-Ice Flow, Temperature Limiting, S/N0339, and surrounding ducts and hardware were sent to QETE for further analysis. QETE was tasked to investigate why the valve was not operating as per designed specification and to confirm if the reported heat discoloration marks on the ducts and clamps could be related to the smoke in the cockpit. QETE reported that the valve was not operating as per specifications. The spring used to regulate the pressure had become worn and slipped over the end of the piston that supplies pressure to the diaphragm (Photos 6-8).

3.1.2 The aircraft experienced multiple failures after take-off because the Valve, Anti-Ice Flow, Temperature Limiting did not function correctly; this caused the ECS system to overheat which in turn caused the duct damage and the smoke in the cockpit. An unserviceable valve (found U/S during previous maintenance on another aircraft) had been re-installed during maintenance.

Photo 6: Disassembled anti ice valve. The spring (right) has become worn and slipped over the end of the piston that supplies pressure to the diaphragm (left).

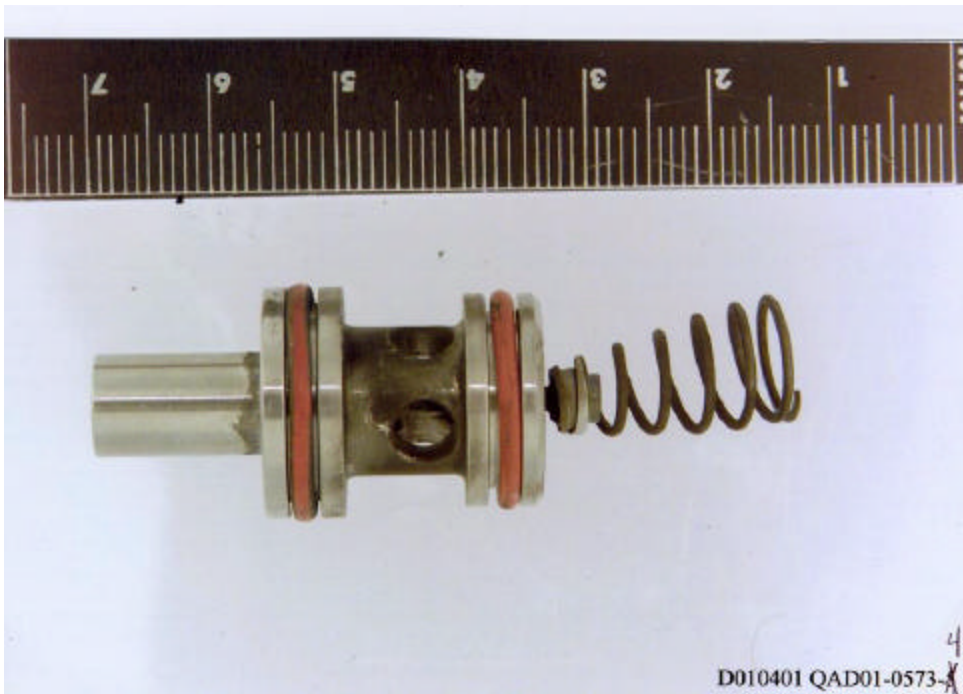
Photo 7: Anti ice valve spring and piston.

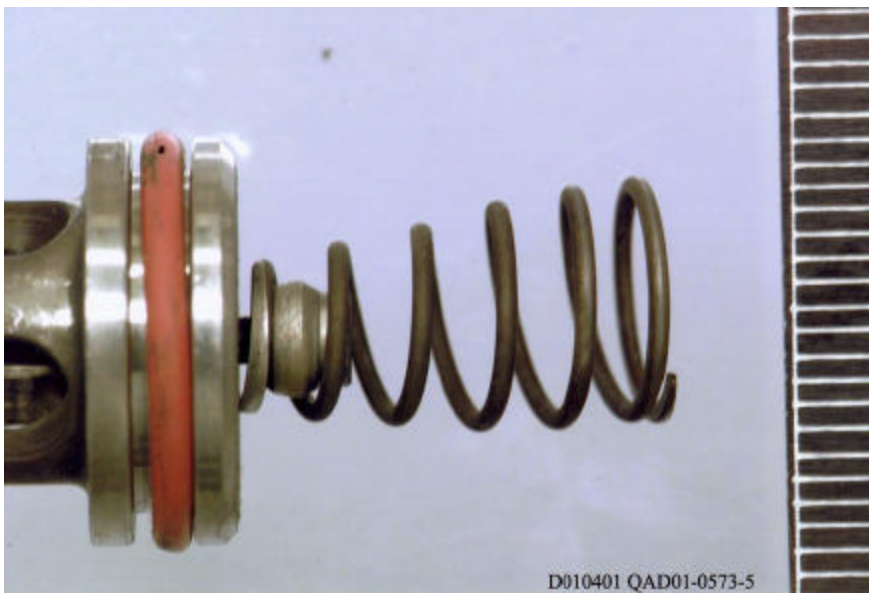
Photo 8: Close-up of anti ice spring and piston.
